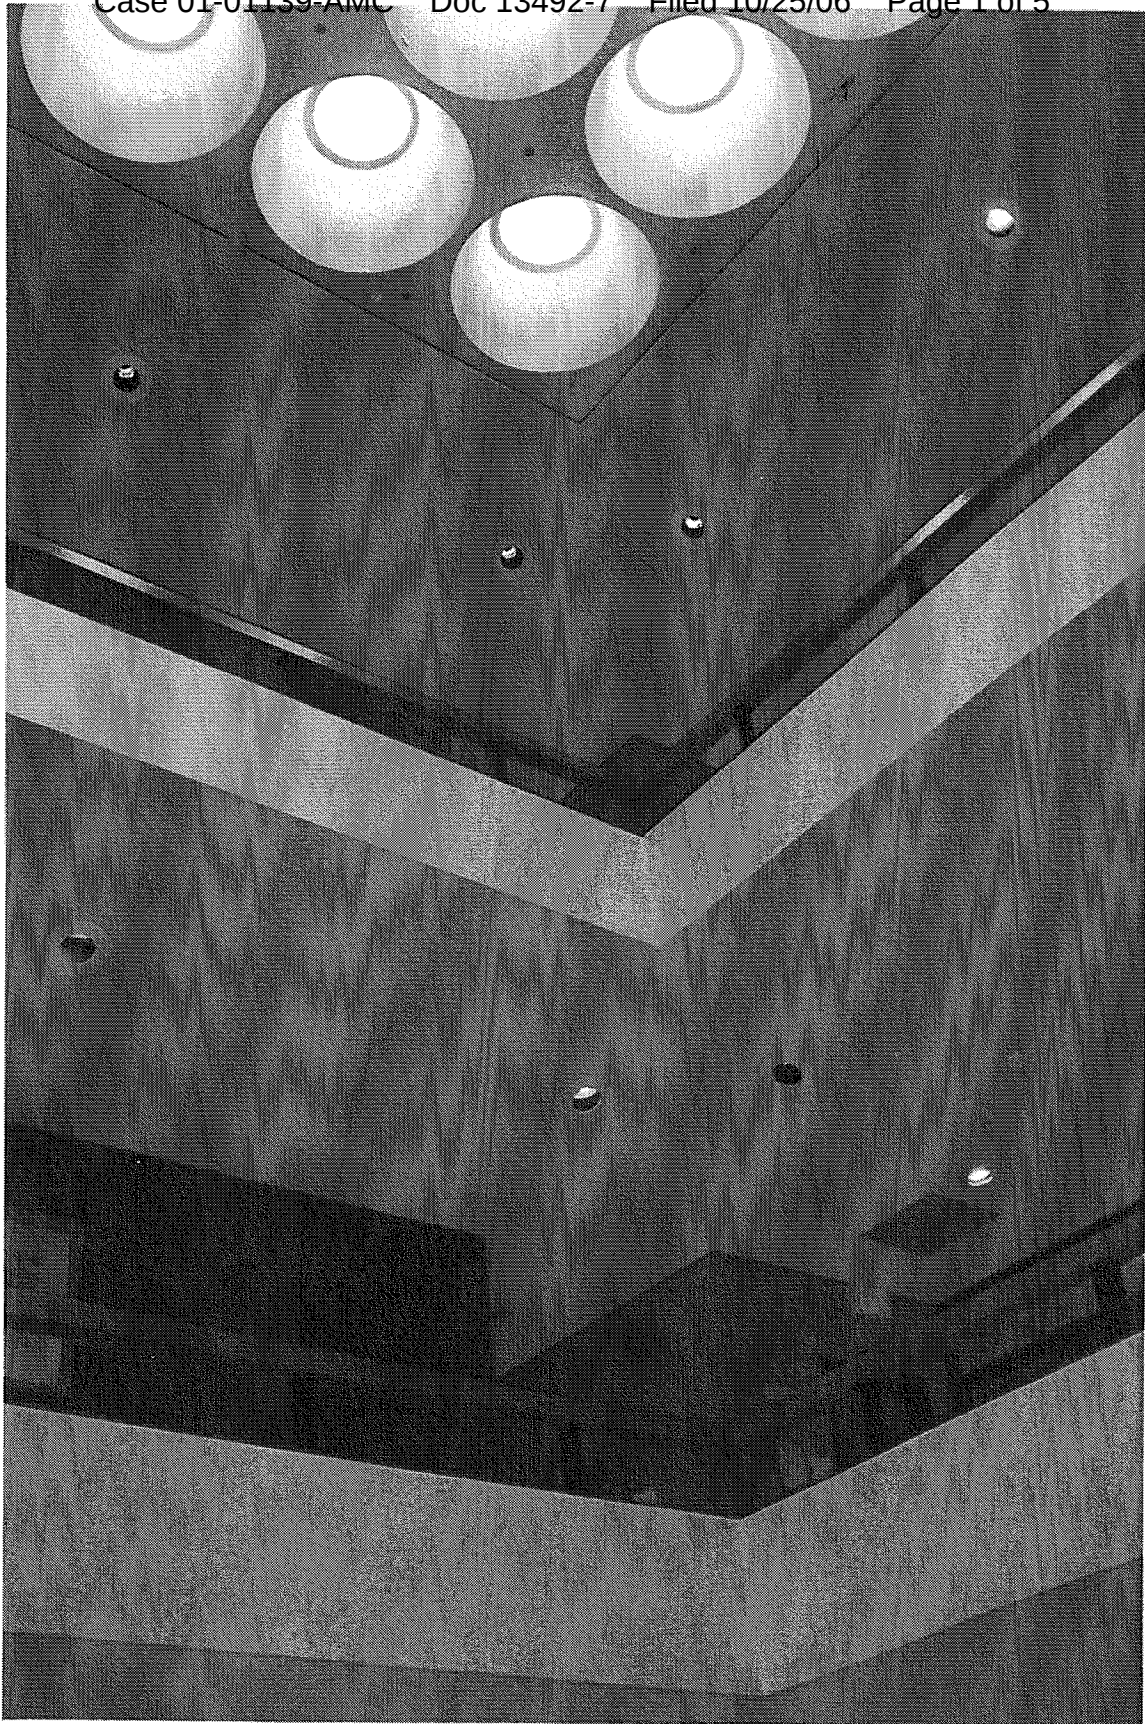
98. 1st floor visitors lounge area - General view of acoustical plaster in atrium lobby/visitors lounge area

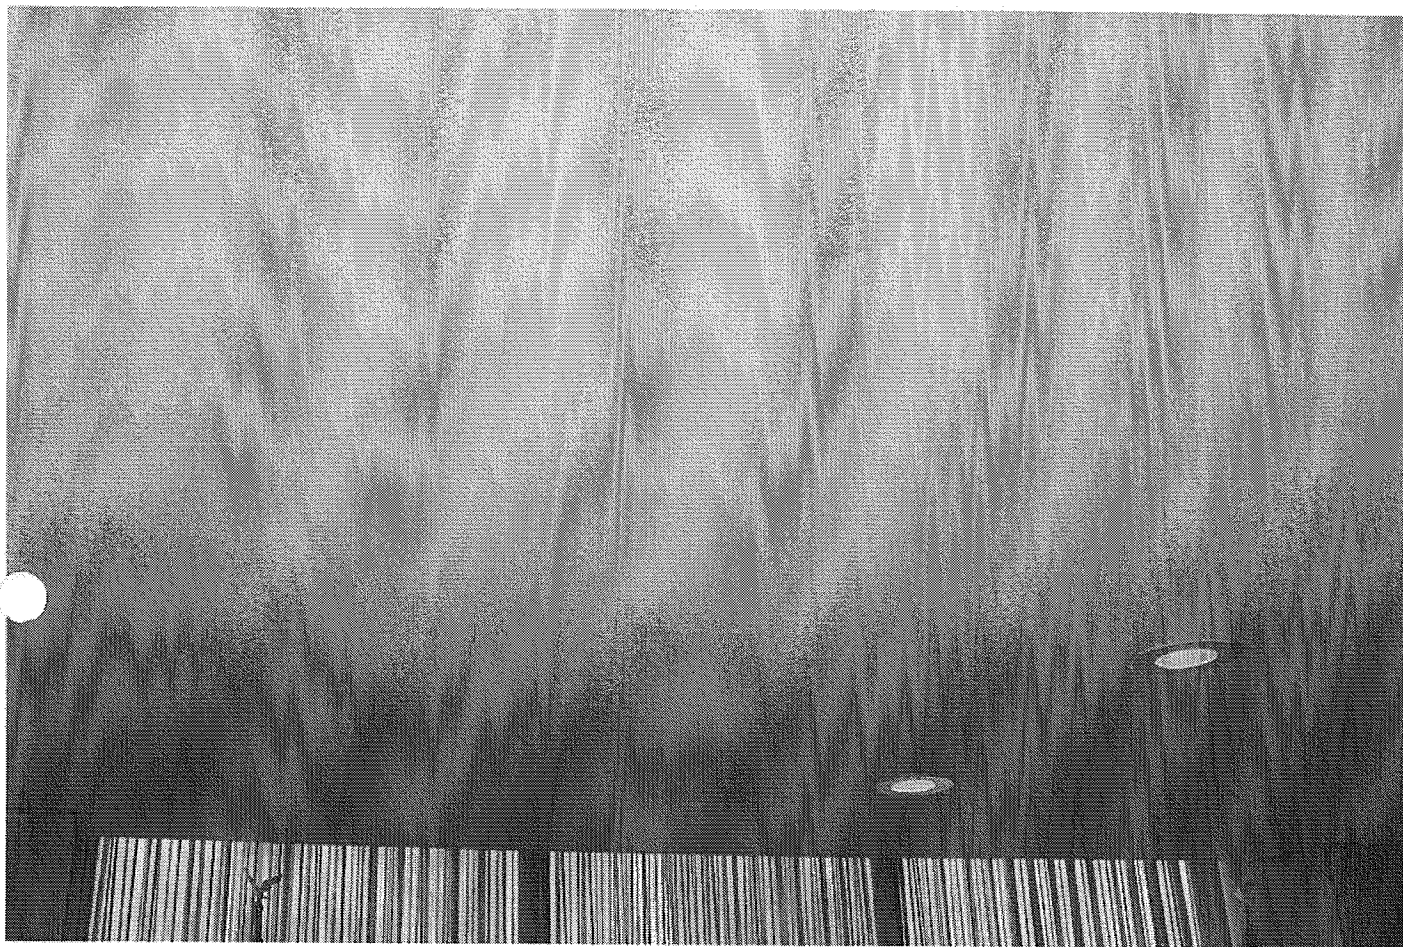
99. 1st floor visitors lounge area - General view of impact damage to acoustical plaster in lobby

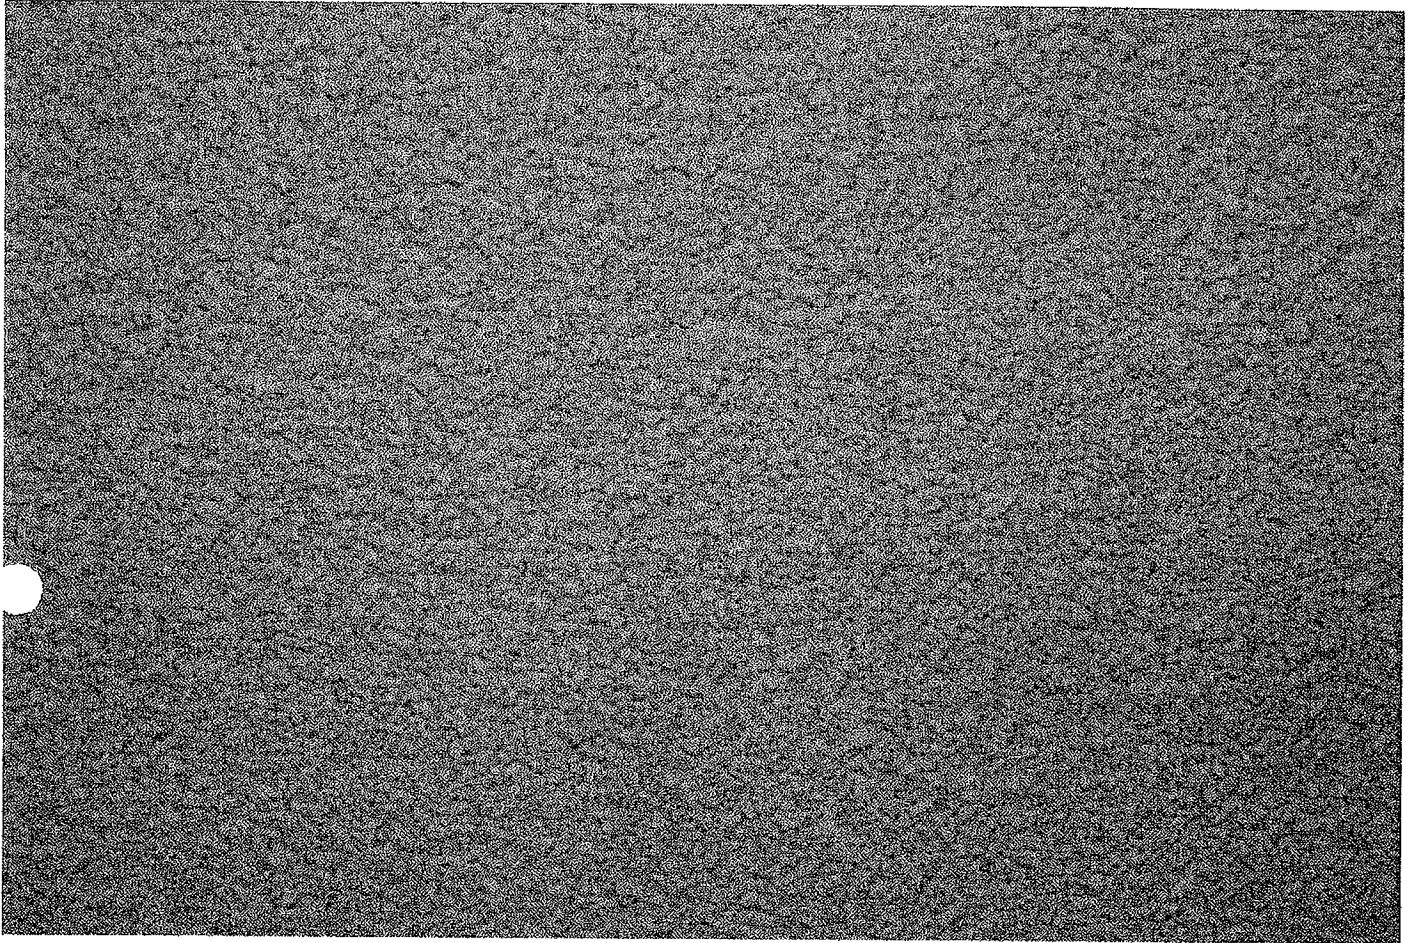
100. 1st floor visitors lounge area - Close-up damage to acoustical plaster near flag pole

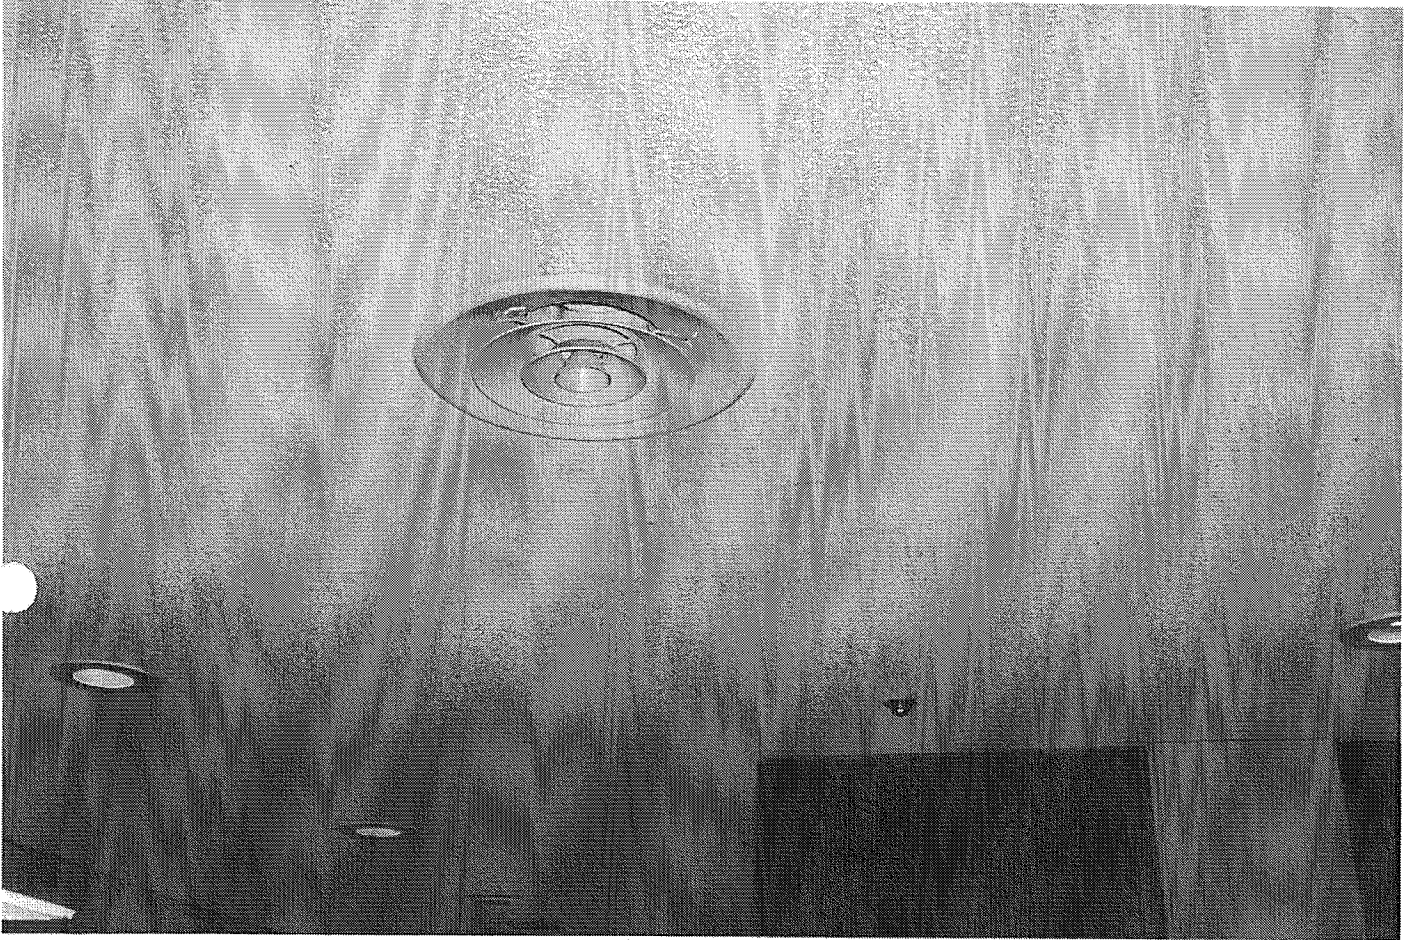
101. 1st floor visitors lounge area - View of water damaged acoustical plaster next to ceiling diffuser

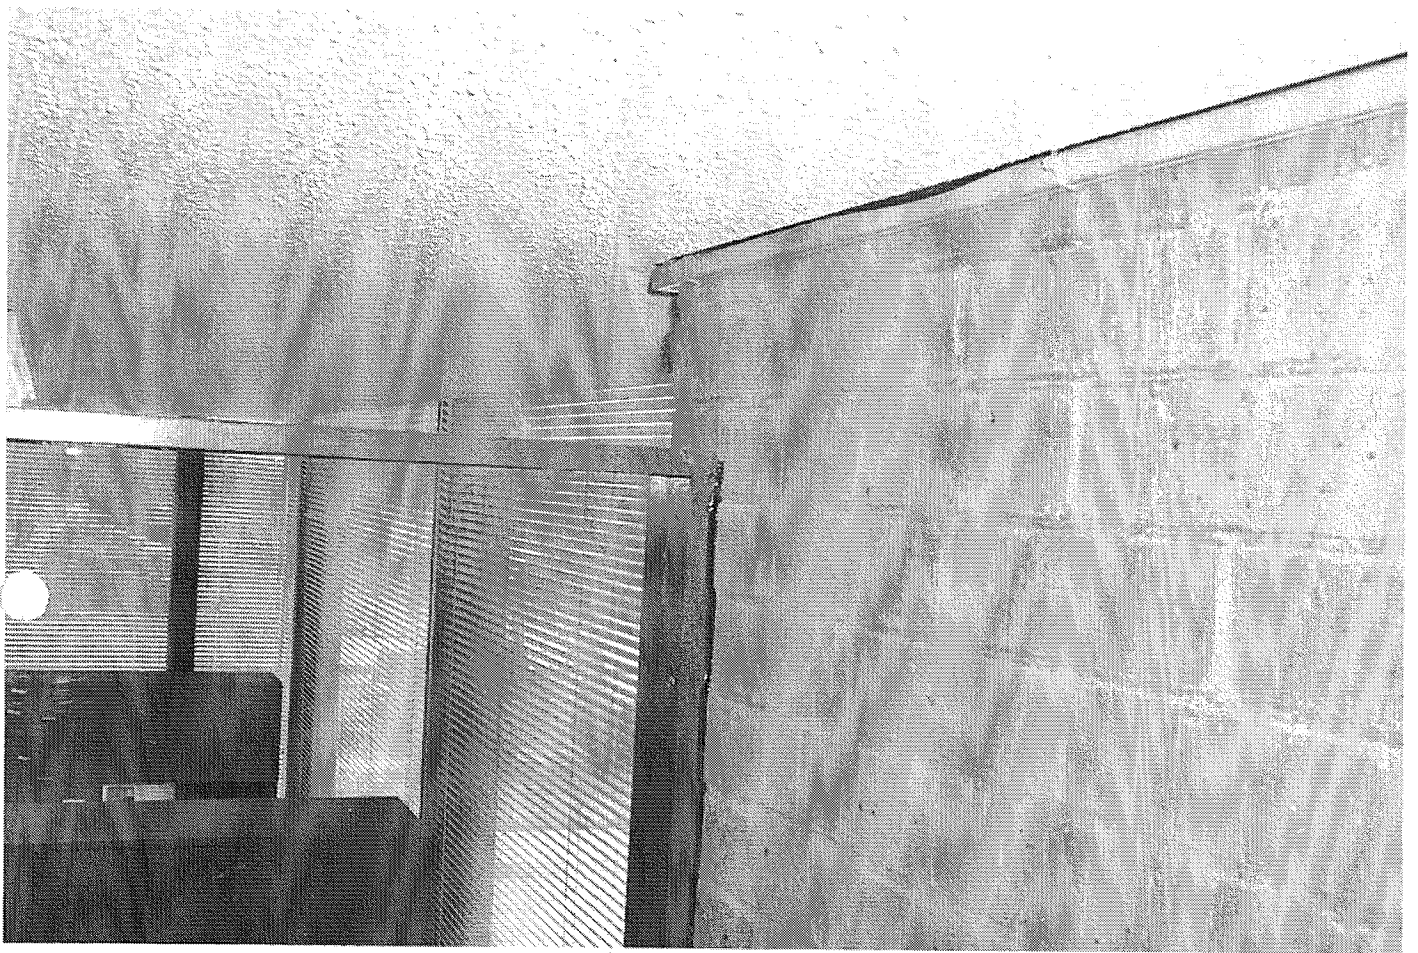
104. 1st floor Sw hallway adj to staff dev - View of acoustical plaster above door to staff development office (general location of dust sample #1)
